NATIONAL TRANSPORTATION SAFETY BOARD

HIGHWAY ACCIDENT REPORT

MULTIPLE-VEHICLE COLLISIONS AND FIRE
DURING LIMITED VISIBILITY (FOG)
ON INTERSTATE 75 NEAR CALHOUN, TENNESSEE
DECEMBER 11, 1990

Abstract: About 9:10 a.m. on December 11, 1990, during fog on Interstate 75 near Calhoun, Tennessee, 99 vehicles were in multiple-vehicle chain-reaction collisions that killed 12 people and injured 42 others.

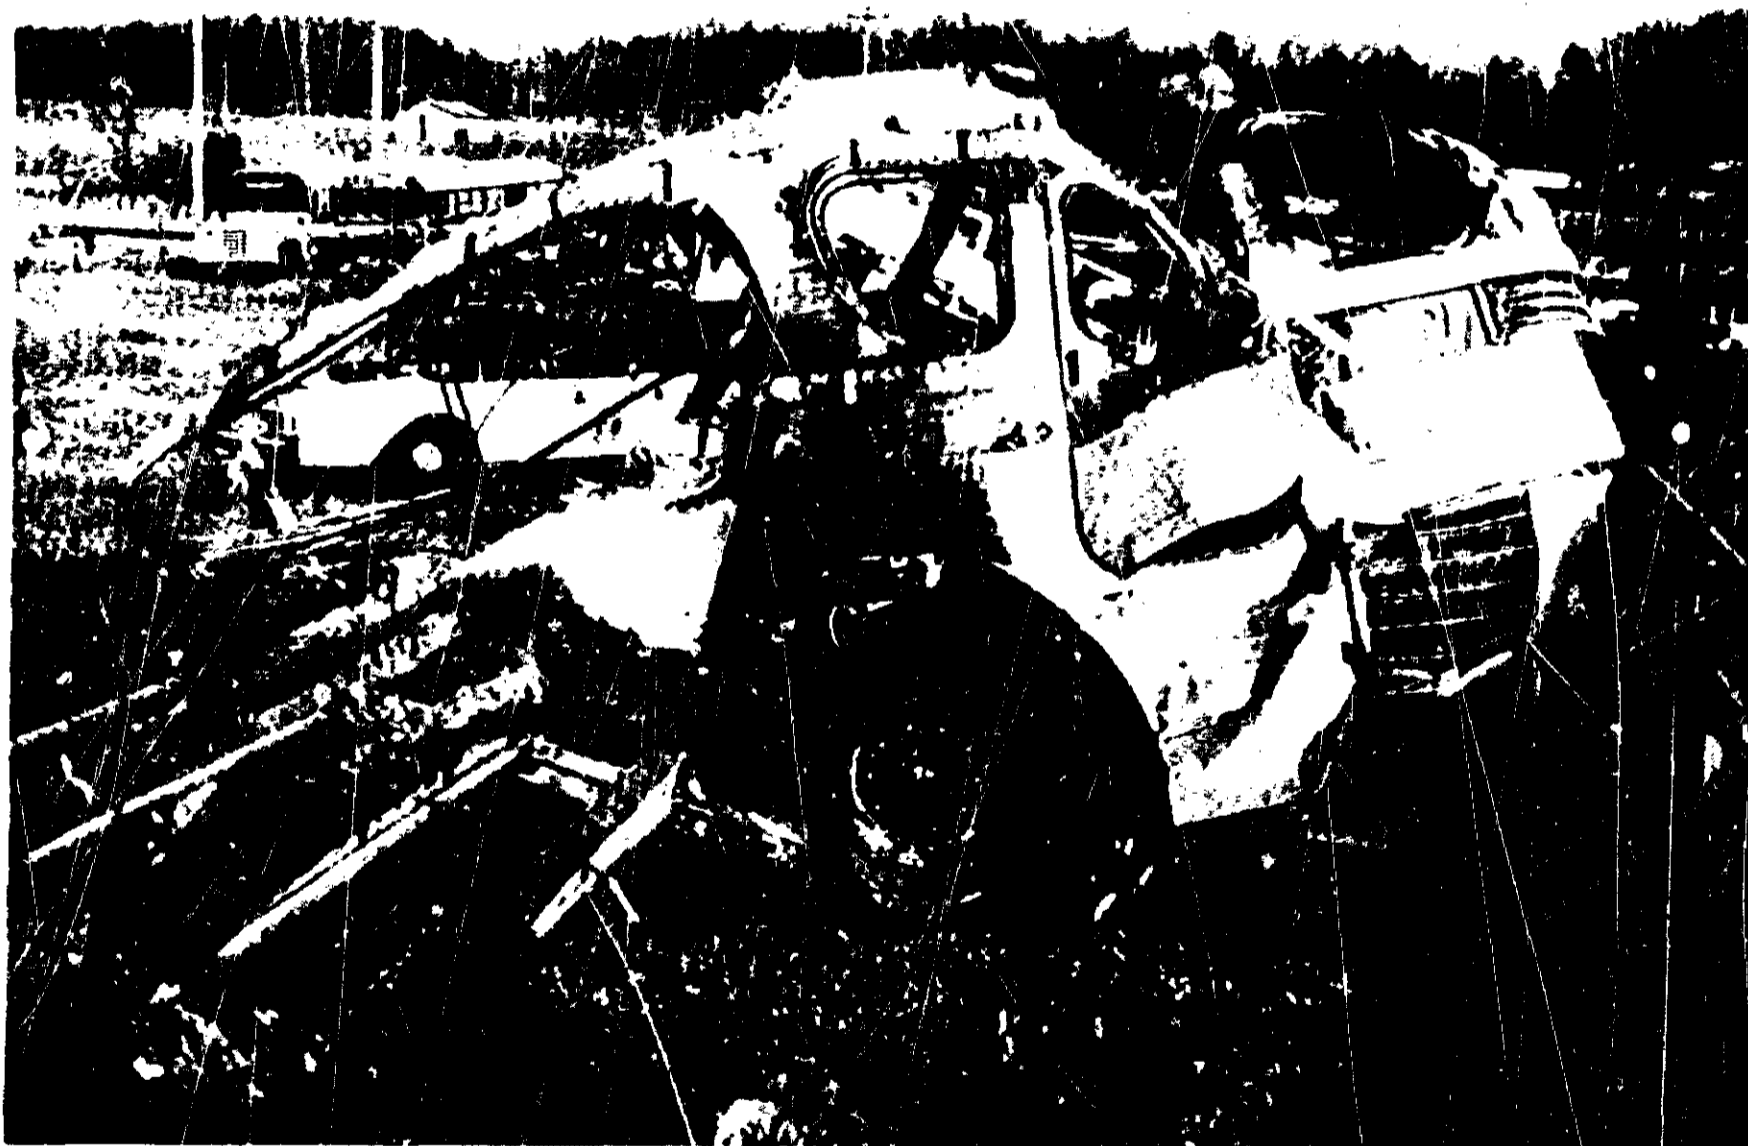
The front of the GMC 4104 intercity bus was incinerated, a small section of its rear remained, the roof was burned, and only the crossmembers remained. The left rear area, including the third and fourth window, and the rear window were all that remained to identify the vehicle as a bus.

The rear and only remaining section of the 1960 GMC intercity bus, converted into a motor home, in which the driver was fatally injured.

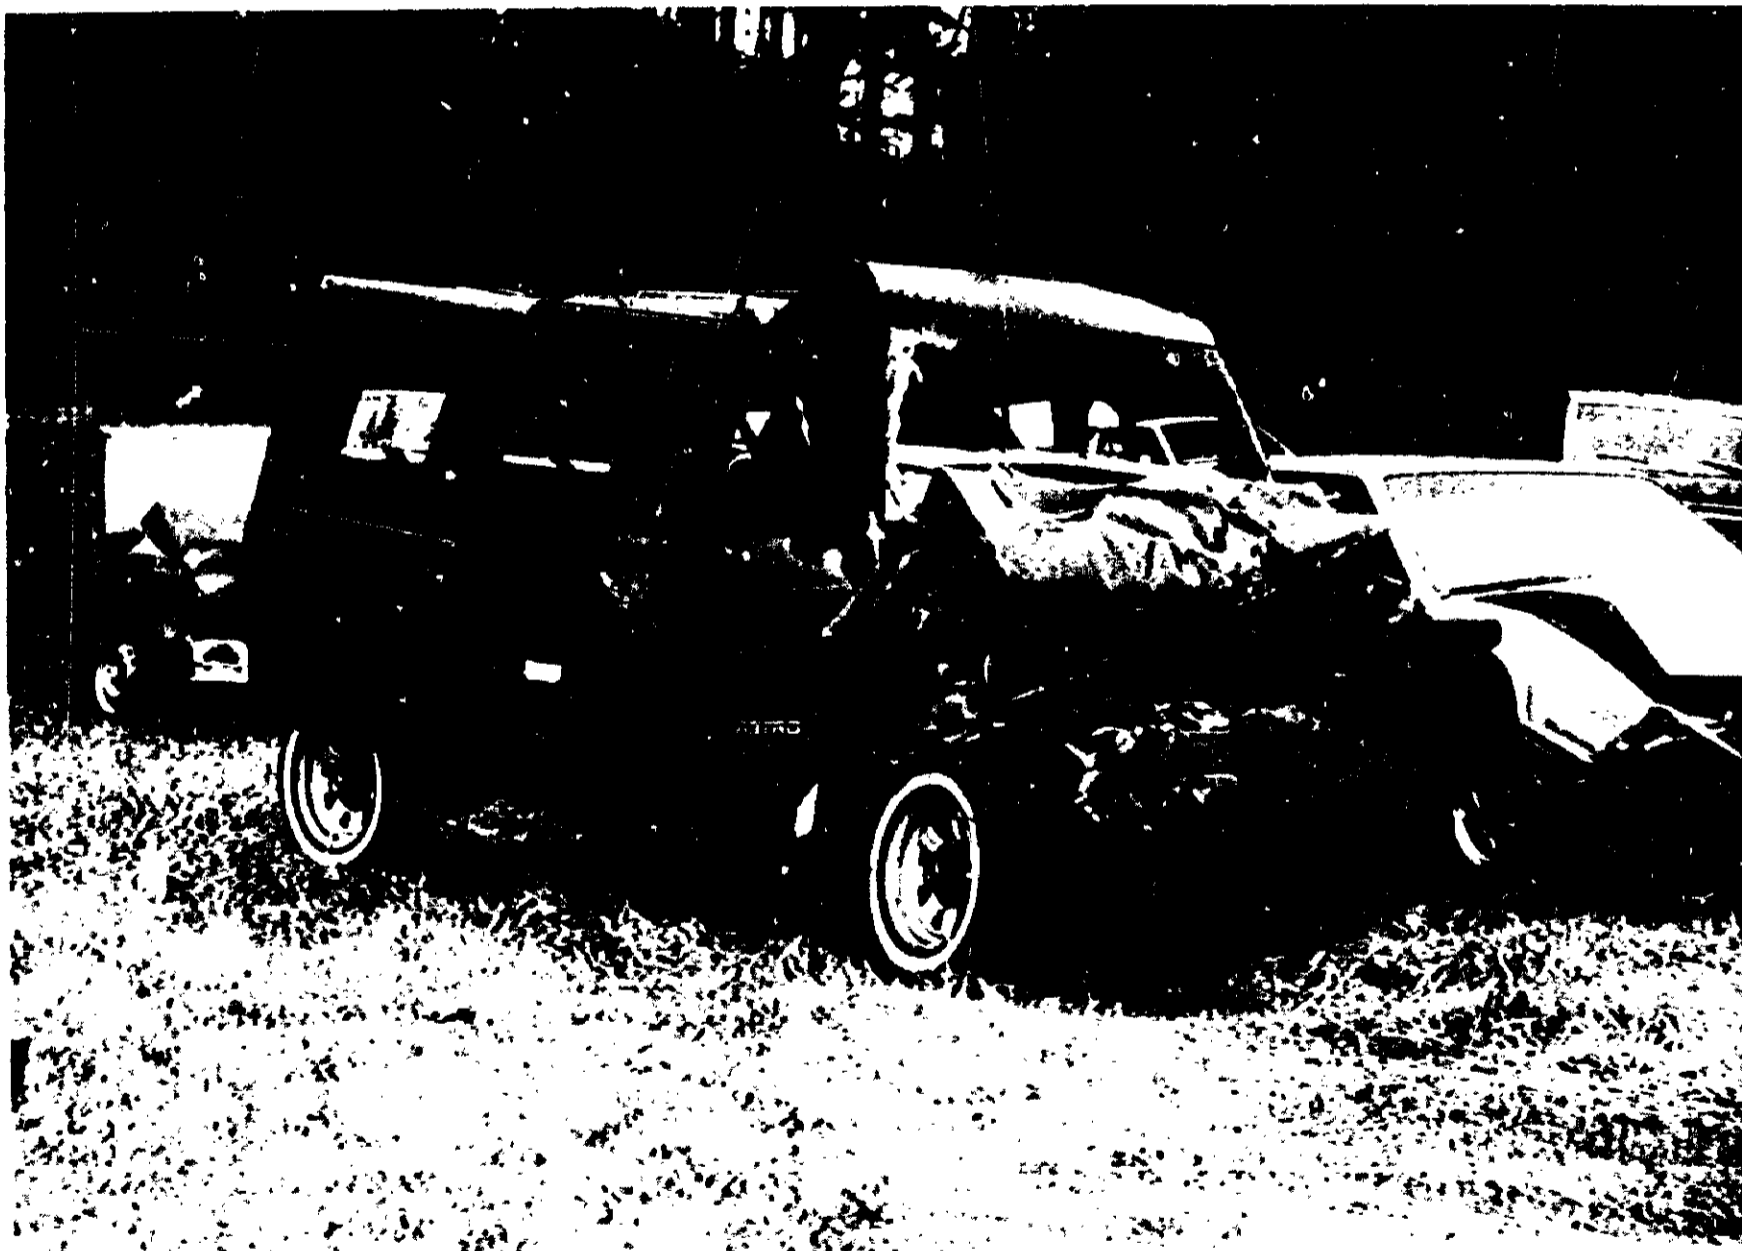
The Astro struck the rear of the tank trailer and was damaged from the front bumper to the windshield, with the hood folded rearward. Both A-pillars were displaced rearward, and the roof above the front seats was displaced upward. The vehicle showed moderate impact damage to the rear doors and recovery damage to the rear bumper where it had been lifted.

The 1989 Astro minivan in which the driver was fatally injured.
